LTPP Seasonal Monitoring Program

Site Monitoring Suspension Status Draft Final Report for GPS Section 310114 (31A) Hebron, Nebraska

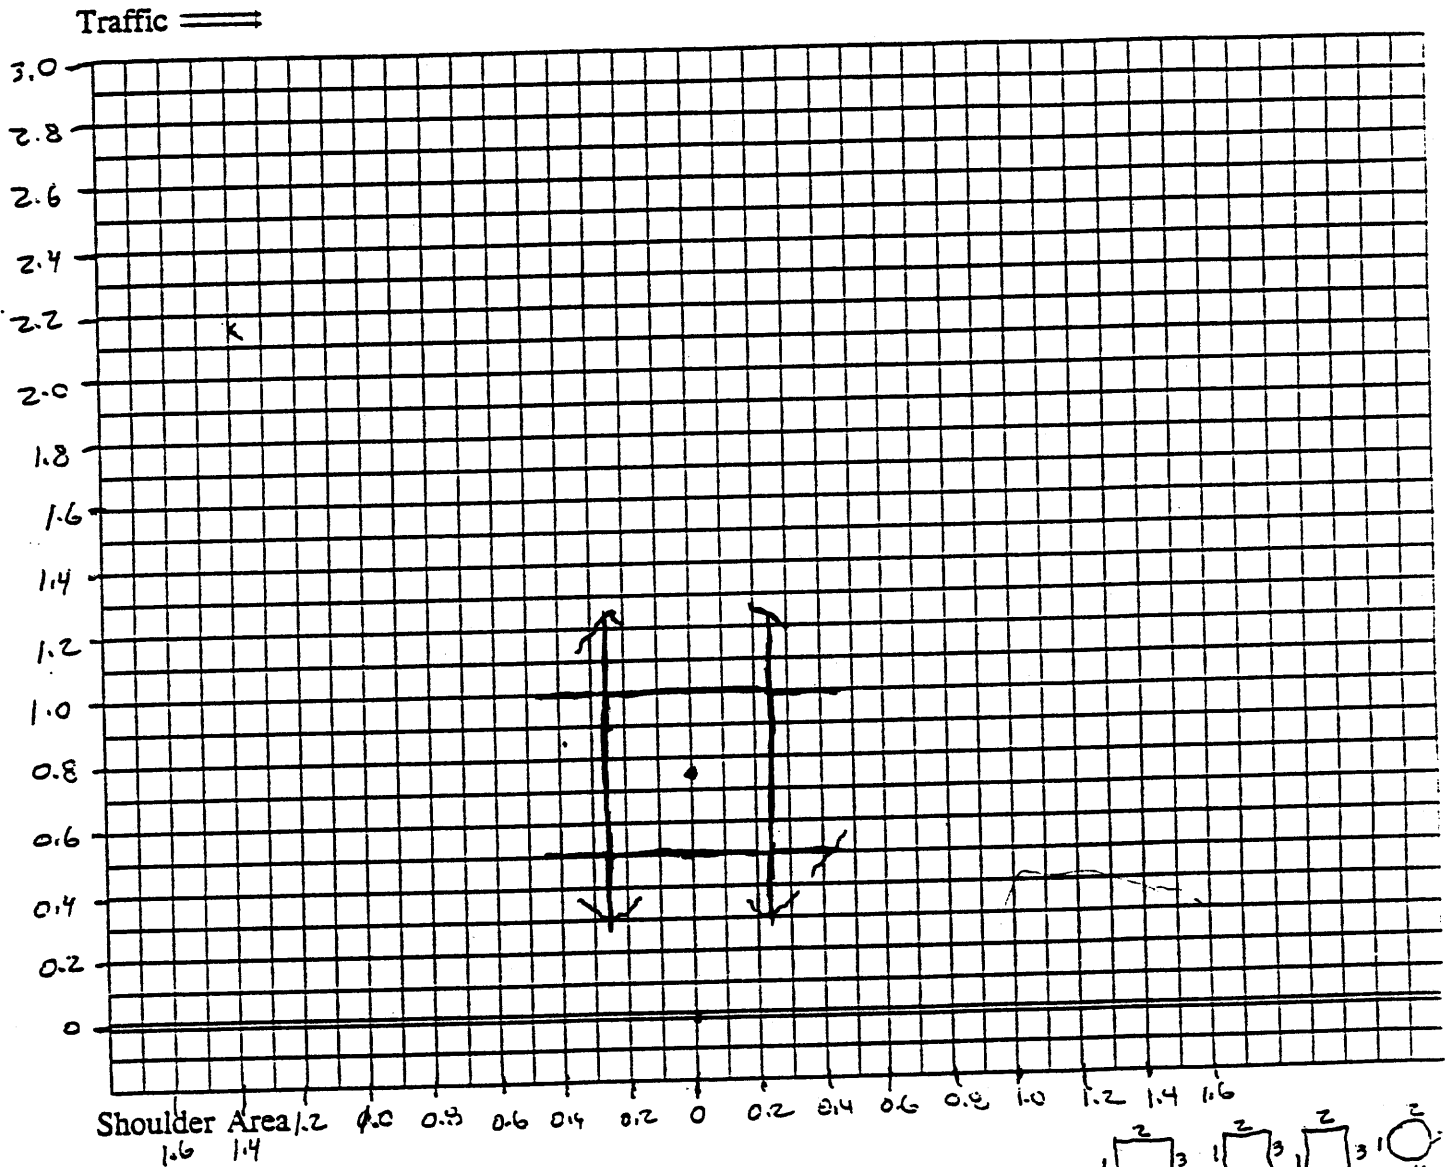
Additional Comments: Significant rutting in test section
possible ponding, and eroded soil on shoulder.
Candidate for rehab/maintenance. Call DOT
regarding these issues.

Location	Settlement, mm			
	Location 1	Location 2	Location 3	Location 4
Instrumentation block/hole	0.1	1.1	0.1	1.1
Trench	N/A	N/A	n/a	n/a

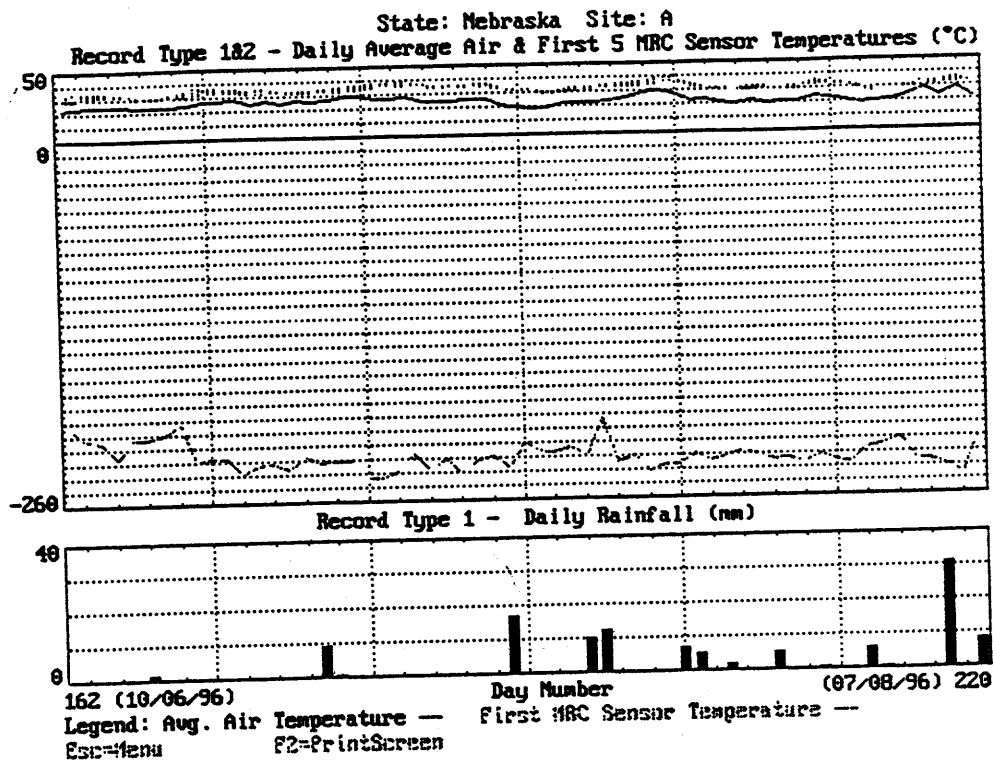
Figure D-1. Profiles for the first five MRC sensors for test section 31SA for the period of June 10, 1996 to August 27, 1996.

A review of the onsite data collected during this visit indicated that MRC sensor 1 did not function as expected from June 10 1996 through August 8, 1996.

As can be seen in the plot presented figure D-1 in appendix D, the temperatures recorded by MRC sensor 1 from June 10 through August 8, 1996 were between -200 and -250 °C. This indicates failure of the sensor. The temperature recordings from the remaining MRC sensors and air temperature measuring sensor appear reasonable and typical of temperatures at this time of the year.

MRC 1 Failure

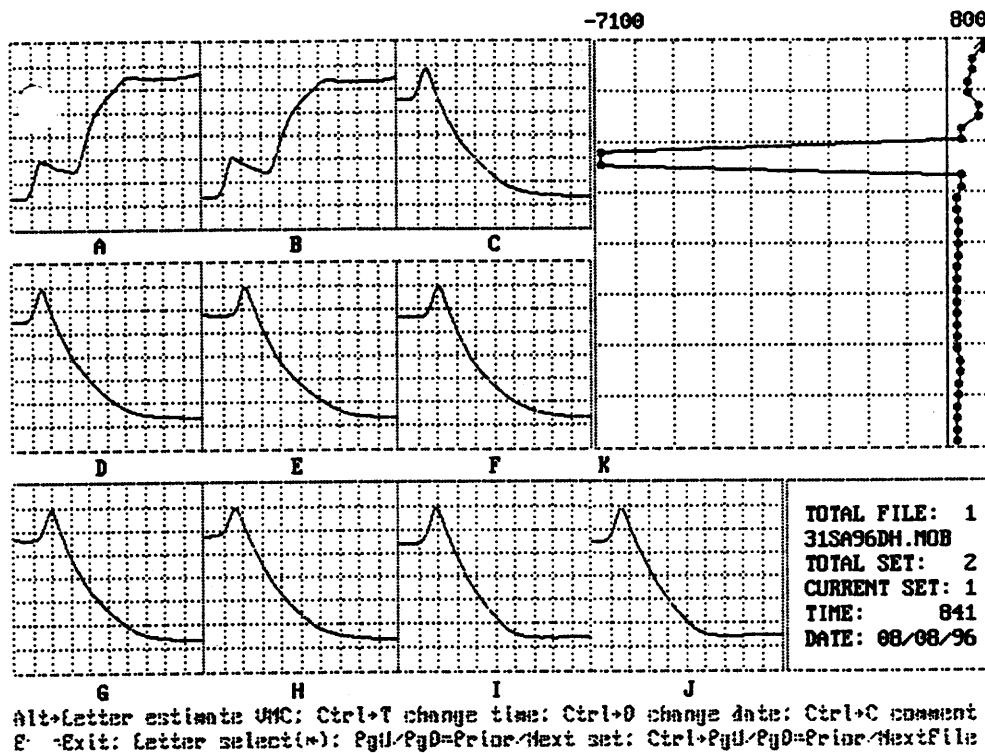
Figure D-2. TDR traces for test section 31SA recorded at 8:41am on August 8, 1996.

A review of the data from the mobile datalogger indicates that the TDR sensors are functioning as expected. All the TDR traces, which can be found in figure D-2 in Appendix D, are typical for this site. The traces had the required characteristics that enable analysis. However, in the same figure, plot K indicates potential problems with the mobile unit, possibly the CRREL multiplexer. As can be seen in plot K, a value of -6999 was noted for locations 10 and 11, suggesting potential problems at these locations in the mobile unit. A review of data from previous visits indicates that this problem existed as early as March 11, 1996.

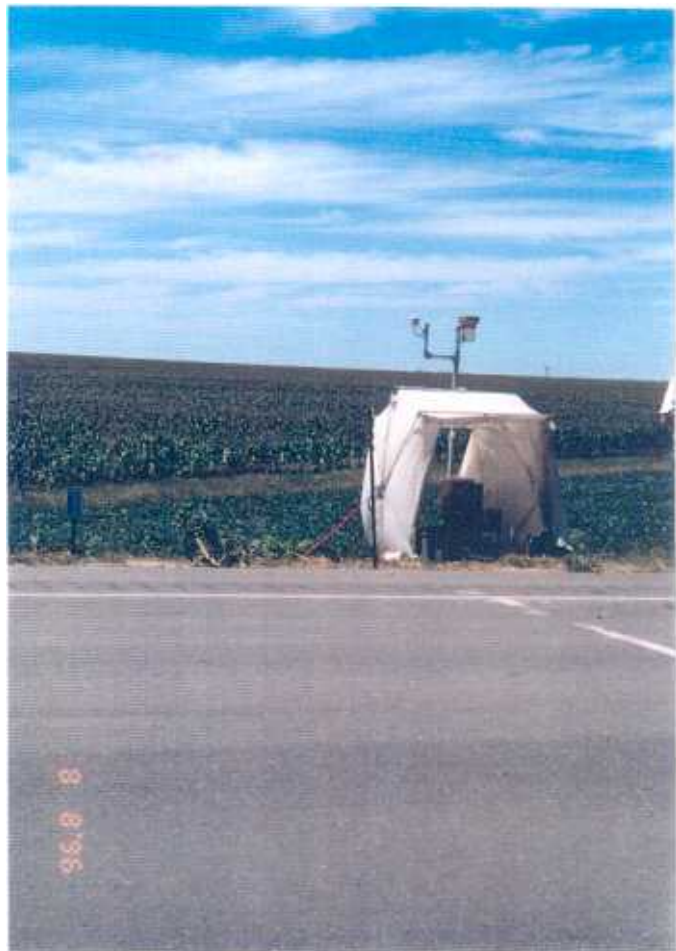
Photograph #1

As shown in photograph 1 in appendix E, the collector unit (funnel) of the rain gauge is intact and the precipitation data recorded by the datalogger in figure D-1 appear reasonable, suggesting the rain gauge is functioning as expected. No obvious problems were noted from the data recorded from June 10, 1996 through August 8, 1996.

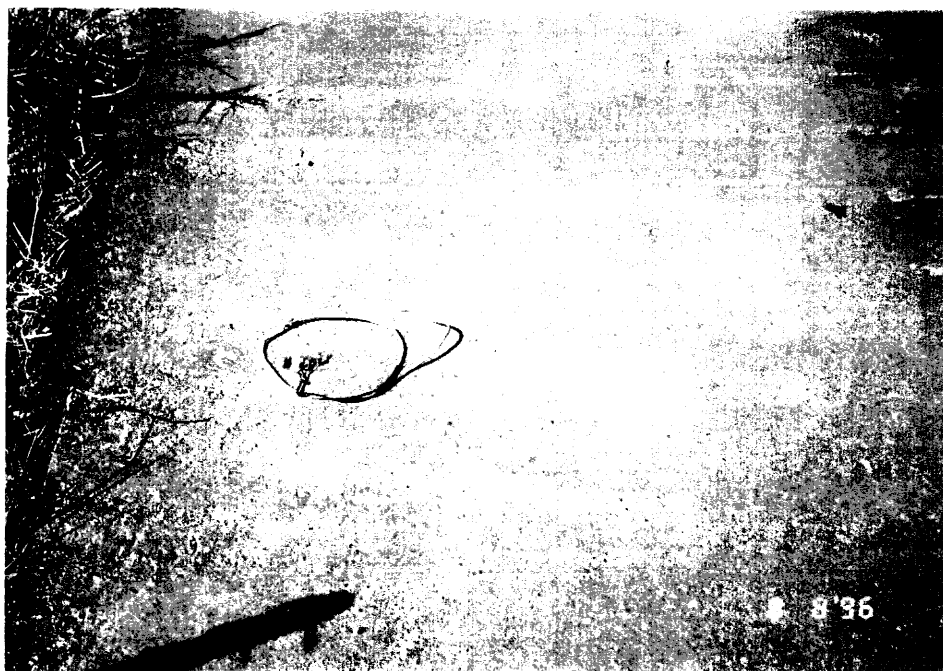
Photograph # 4

was left onsite in the cabinet. A new air temperature sensor has been ordered to replace the one with wires that were damaged during de-installation.

Photograph 4 shows the damaged electrical wires.
